Examples of peeling paint on concrete and crumbling concrete on bases of houses in the COP HOA.

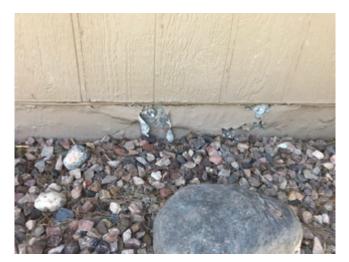
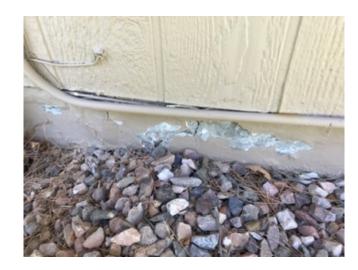
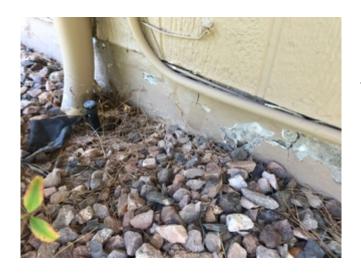
I spoke to the cement contractor who was working in the neighborhood today. I showed him the issue of peeling and crumbling concrete on the concrete slabs of our houses. He said that this condition is caused by excess moisture laying next to the houses. The bubblers are too close to the houses. They need to be moved further away from the foundations and the areas patched in order to stop this condition.
